## ADDENDUM

**Ireland Farm**  
**CT-26**  
**2133, 2165, 2169 Wilson Road**  
**Huntingtown, Maryland**  
**Amy Bolasky Skinner**  
**The Ottery Group, Inc.**  
**August 7<sup>th</sup>, 2009**

### **Section 7. DESCRIPTION**

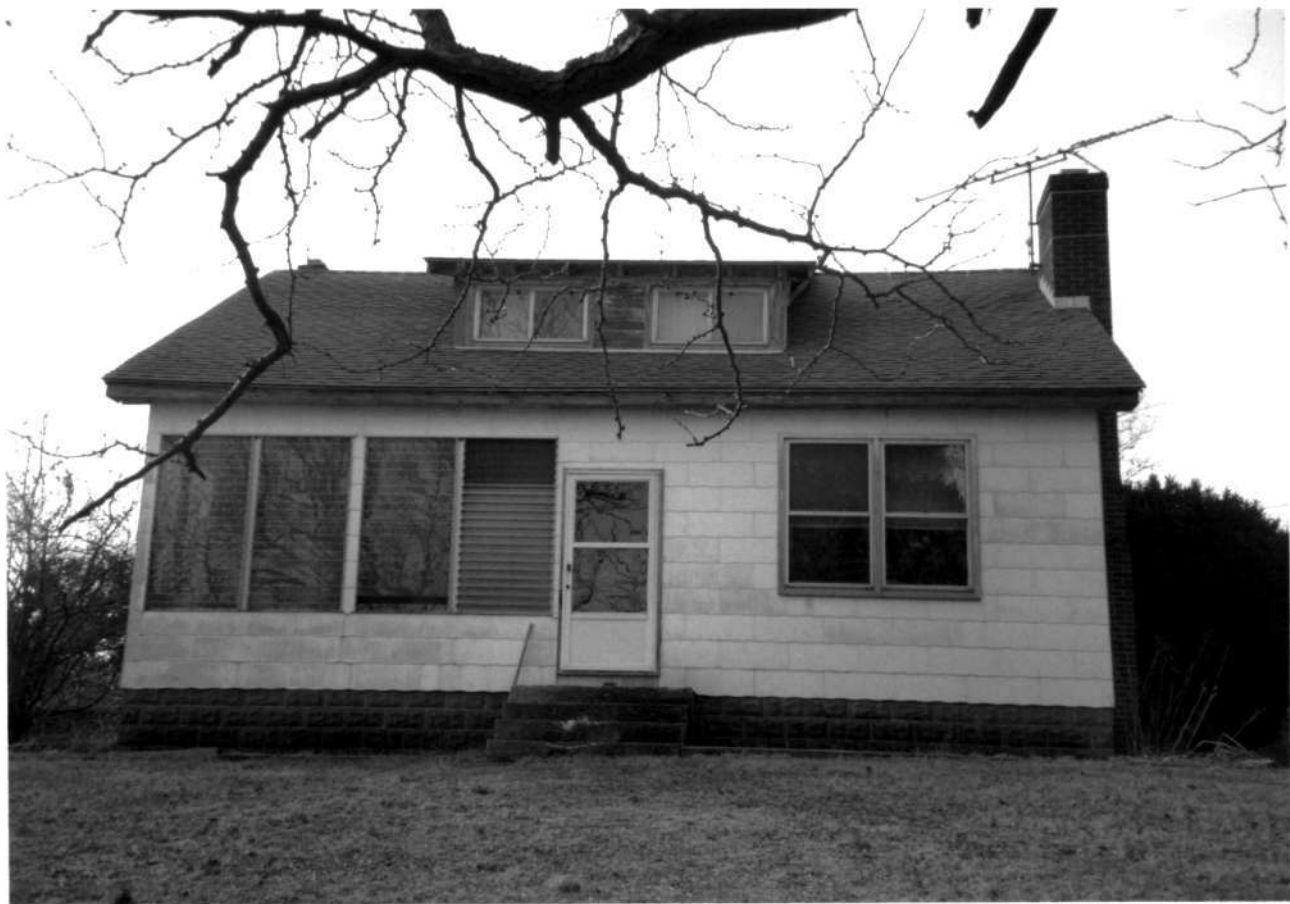
1 of 60

Small House Facade North

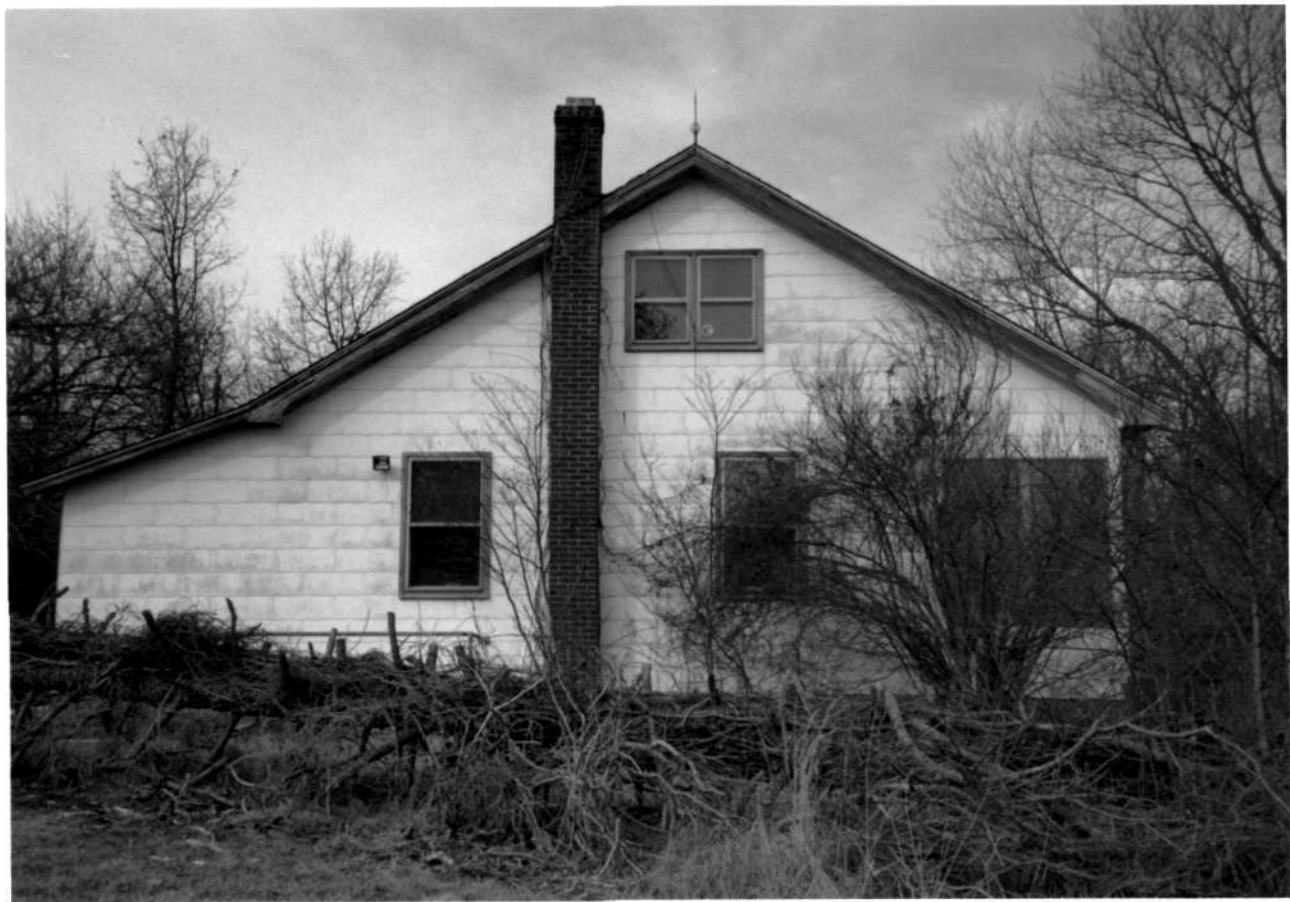
2 of 60

Small House Elevation East

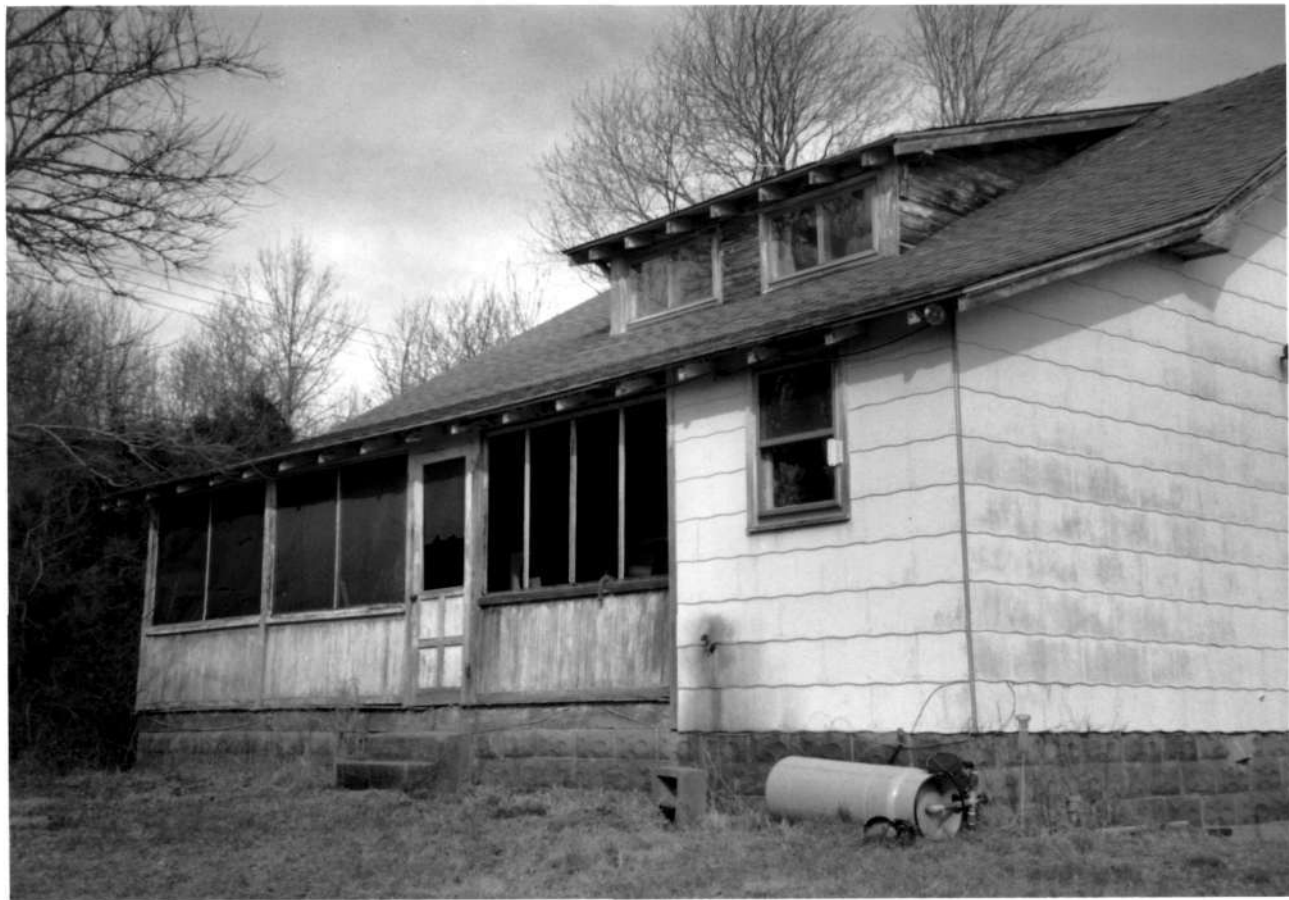
3 of 60

Small House Elevation South

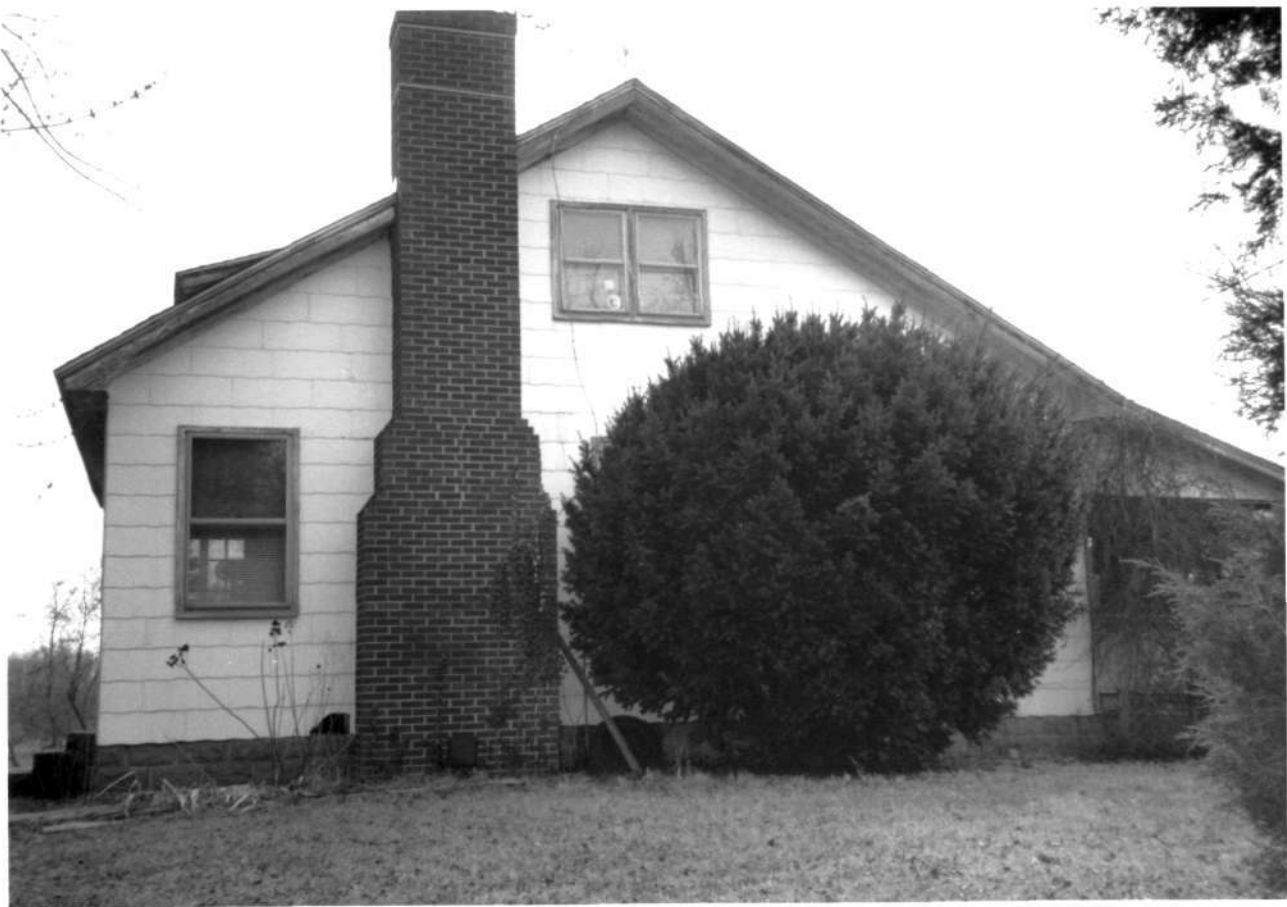
4 of 60

Small House West Elevation

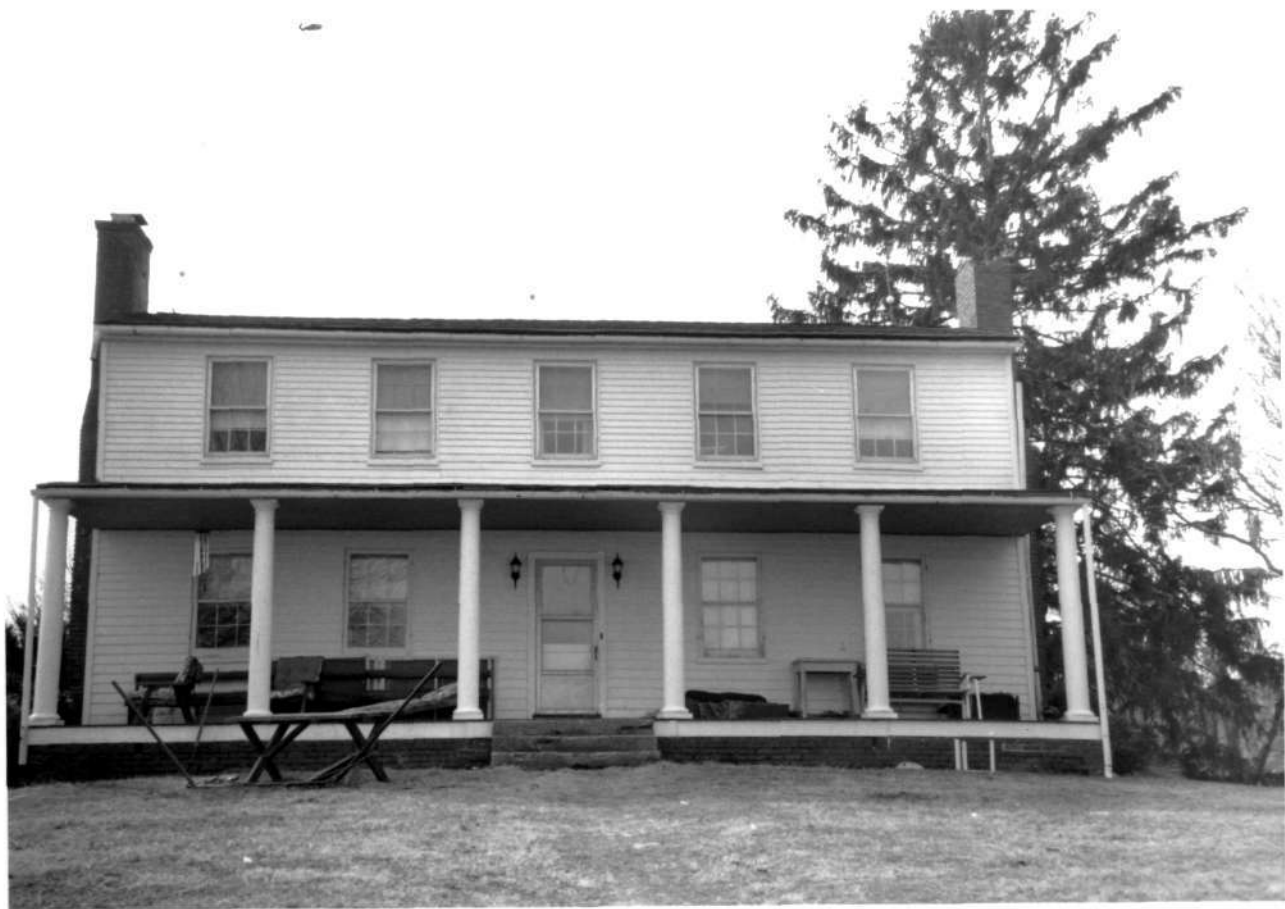
7 of 60

The farmhouse is a two-story, five-by-two bays dwelling with an ell-shaped plan. The shallow pitched, side-gable roof is clad with asphalt shingles and has a thin cornice. There are two large, exterior end chimneys on the main house block. The chimneys are brick, with double-flues and corbelled caps. The house is wood-frame with a brick foundation. The exterior is clad in weatherboard with corner boards. The fenestration is symmetrical with single, six-over-six, double-hung sash wood windows on the north façade. A full-length shed-roof porch extends across the north façade supported by wood, Tuscan columns. The roof has as a shallow pitch and is clad with asphalt shingles.

Main House North Facade

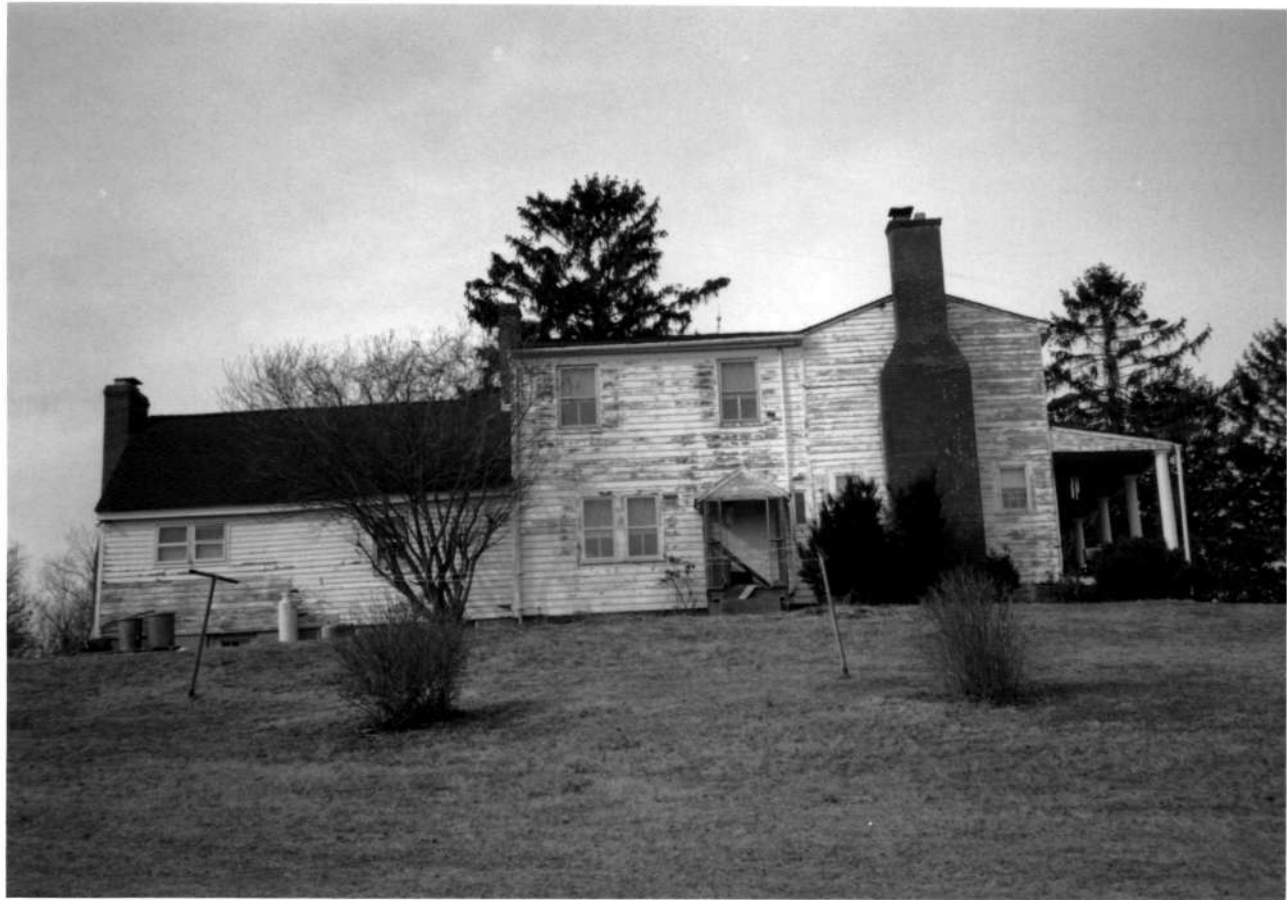
8 of 60

Main House East Elevation

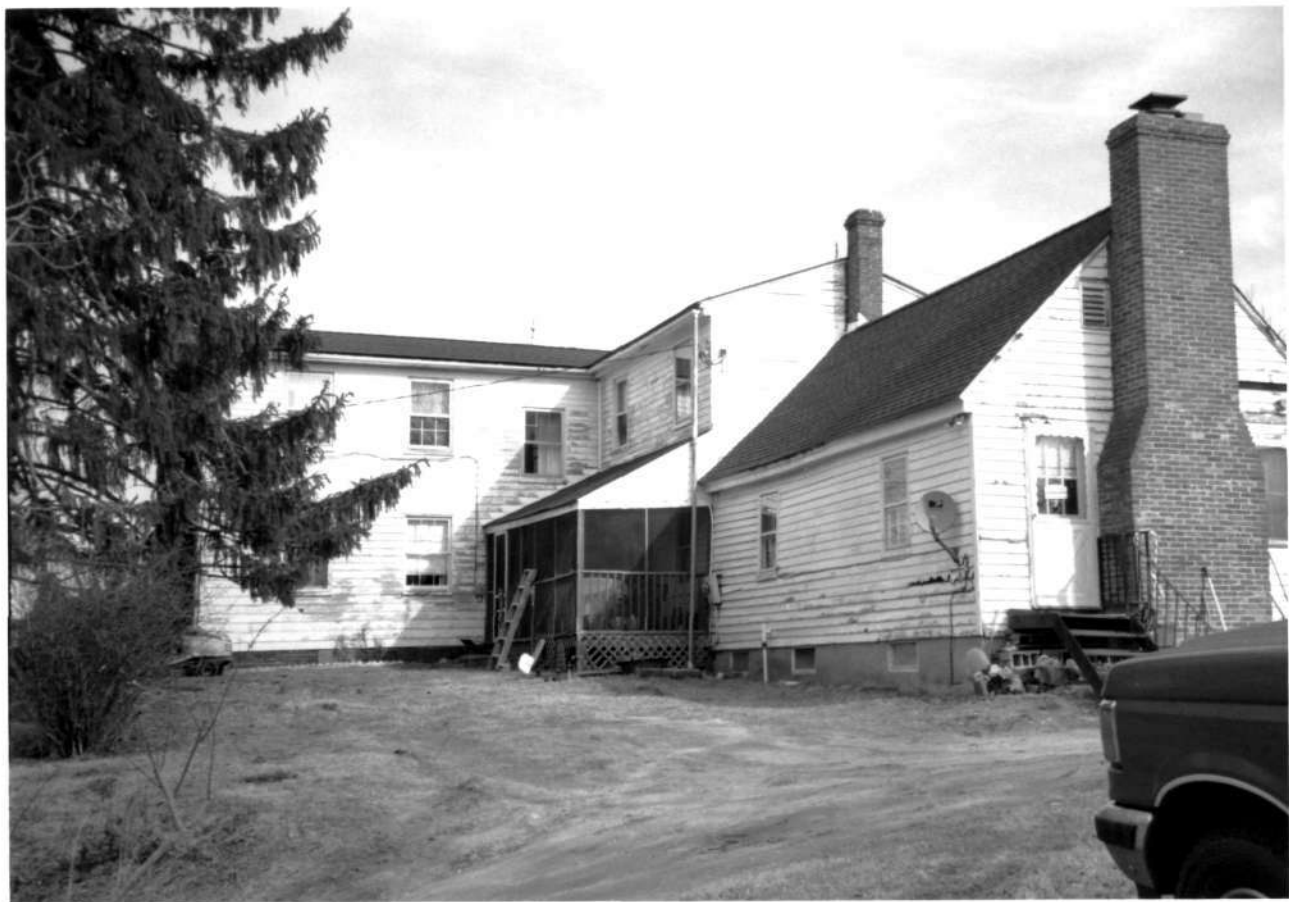
9 of 60

Main House South Elevation

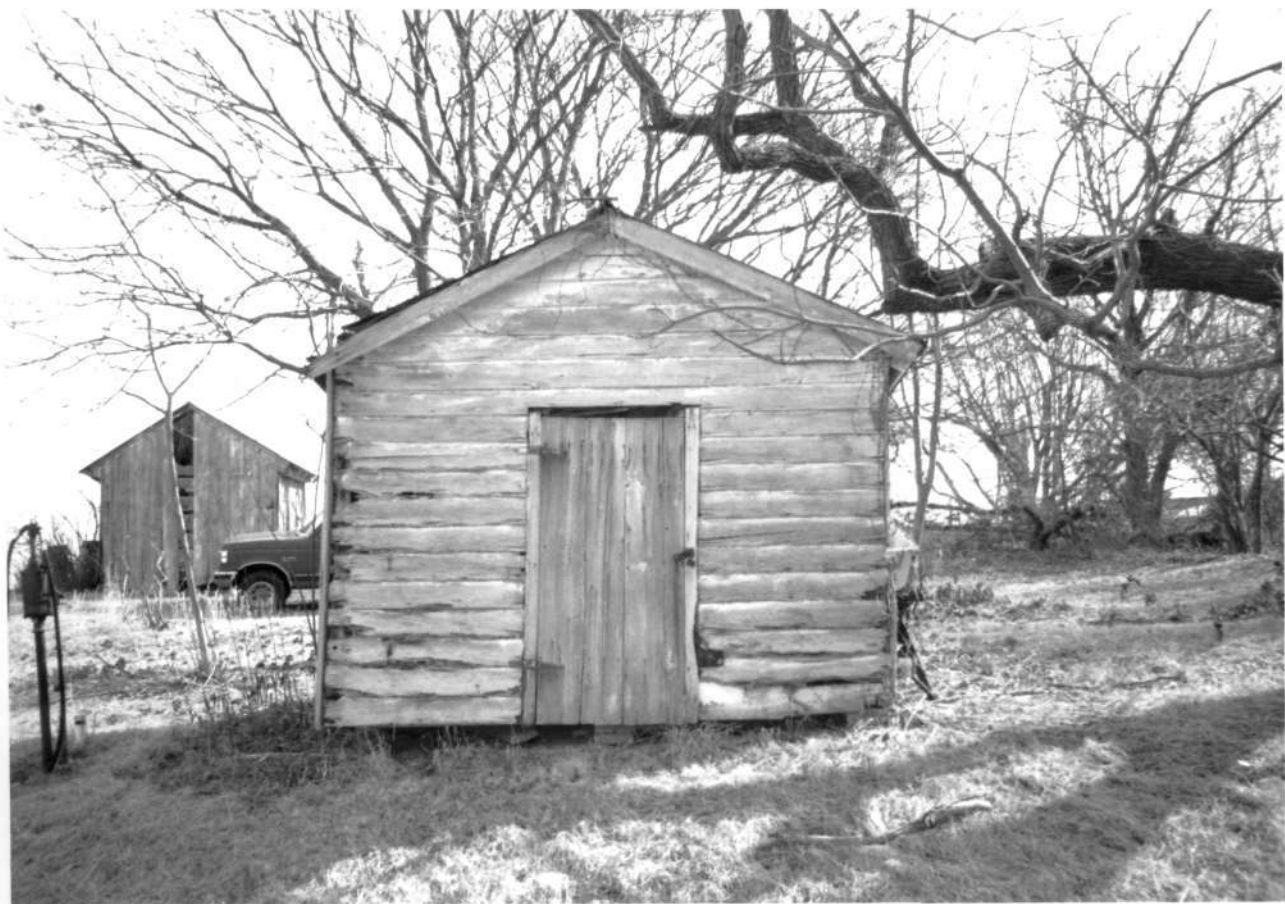
15 of 60

Shed Two is located directly south of Shed One to the southwest of the main house. Shed Two is accessible off of the dirt access road and sits above the road on a slope. The outbuilding is a one-story, one-by-one bay building with a rectangular plan. The shallowly pitched, metal standing seam, front-gable roof has overhanging eaves. The building is of wood-frame construction with a brick pier foundation. The exterior is clad in rough-hewn weatherboard. There is a wood plank entry door on the west façade and a ribbon of four, fixed, two-pane wood windows on the south elevation. Due to its proximity to the storage barns as well as fenestration on the south elevation, Shed Two could have been used as a tool shed or workroom. The shed is no longer stable, sloping to the south and east. The exterior weatherboard is deteriorating at the corner boards on the west façade and is no longer weatherproofed.

Shed 2 West Facade

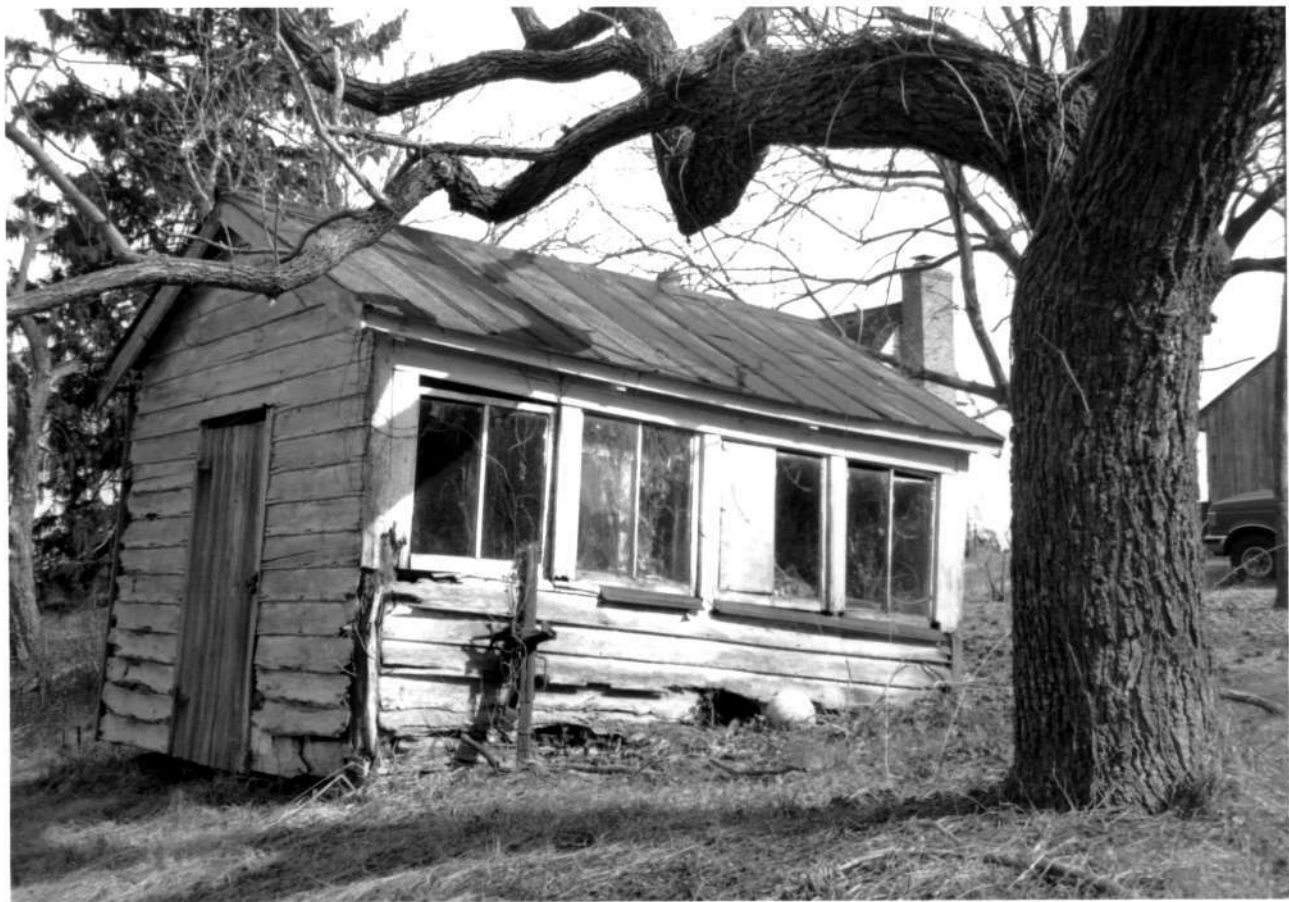
16 of 60

Shed 2 South Elevation

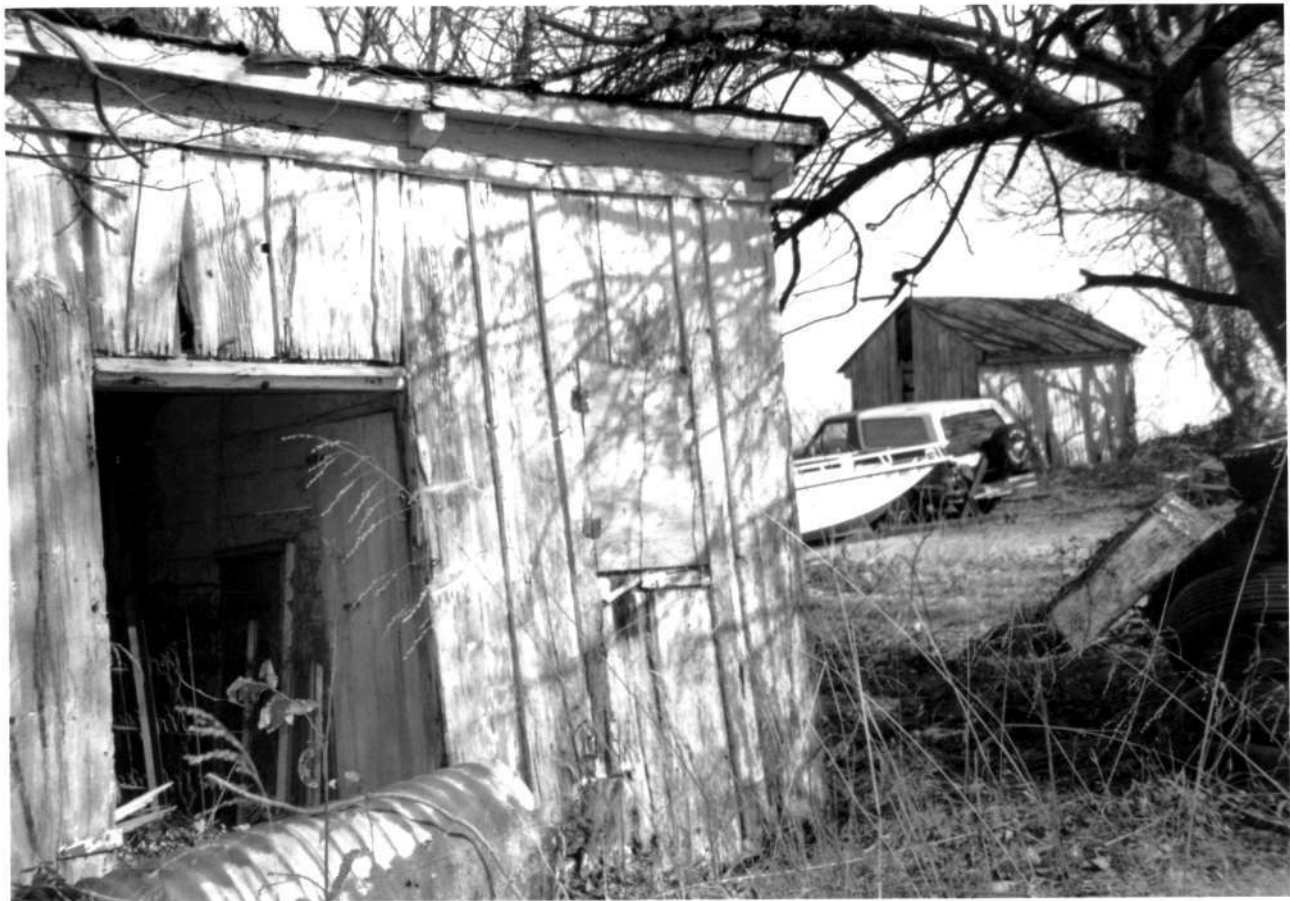
17 of 60

Shed Three is located directly south of Shed Two to the southwest of the main house at the edge of a forested area. Shed Three is accessible off of the dirt access road and is located across from Barn Two. The outbuilding is a one-story, one-by-one bay building with a rectangular plan. The shallowly pitched, metal standing seam shed-roof has exposed rafter tails. The building is of wood-frame construction with a foundation that is not visible. The exterior is clad in vertical wood planks of varying widths. There is a central opening on the south façade. There is a fixed, two-pane wood window on the south façade's western bay and a "cut out" on the south façade's eastern bay. The cut out is sealed with a batten plank "shutter" and iron hinges. There is one fixed, one-pane window on the north elevation. The middle section of the building is an open shed with a partition separating the east portion of the shed. Due to its form, Shed Three could have been used to house animals, possibly as combination a chicken coop and rooster house. The shed-roof is sagging and the building is no longer weatherproof as some planks are fully or partially missing.

Shed 3 South Facade

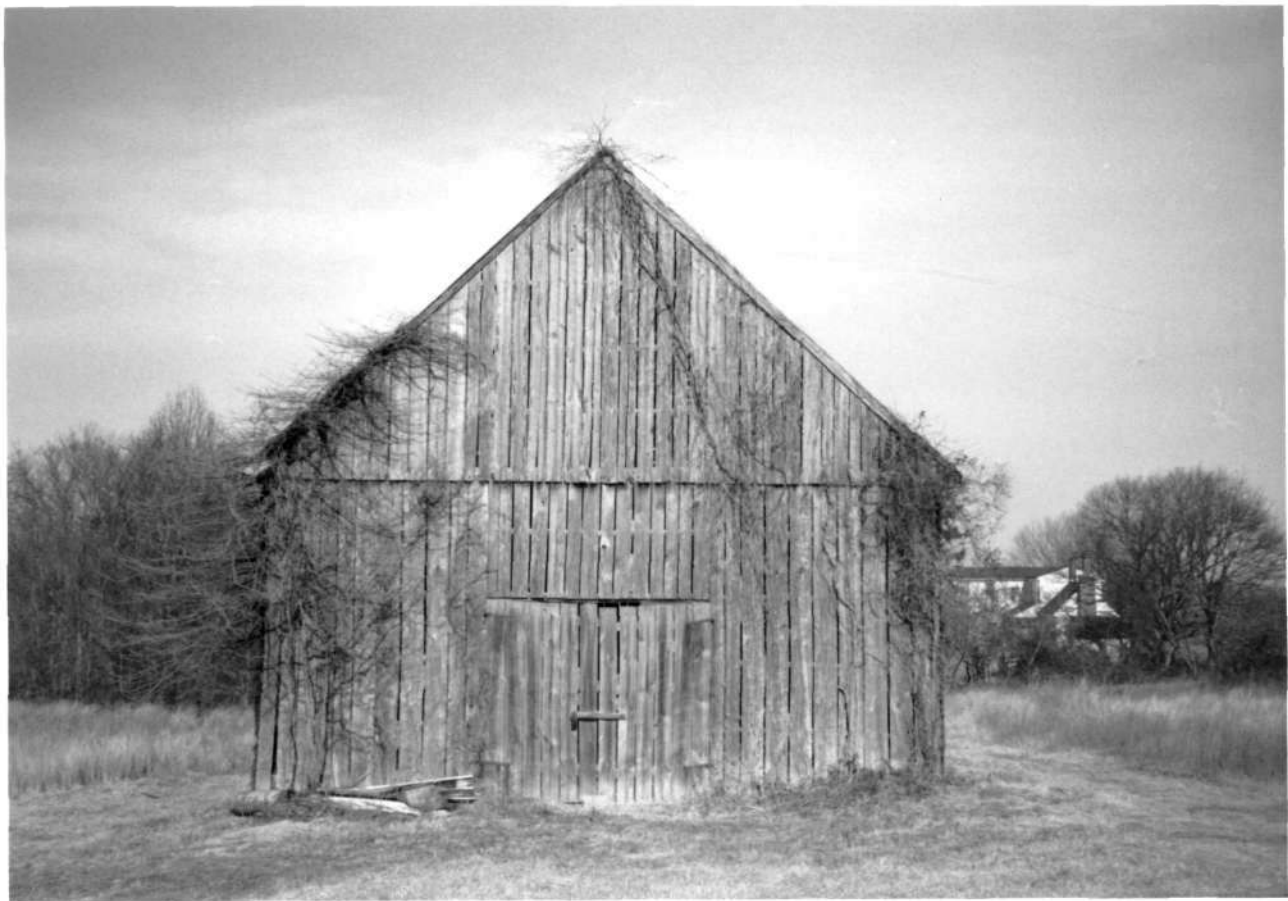
20 of 60

Barn One has a steeply pitched, metal standing seam, front-gable roof. It is a typical example of twentieth century tobacco barns in Calvert County with its double-aisle plan and interior stripping room. The exterior is clad in machine-cut, vertical planks that are not flush with one another and vary in width. Unlike many twentieth century tobacco barns, Barn One's exterior vertical planks do not have vertical ventilation doors. The barn is wood-frame, the trussing system of drying poles is indicative of the barn's use as a tobacco barn.

Barn 1 South Facade

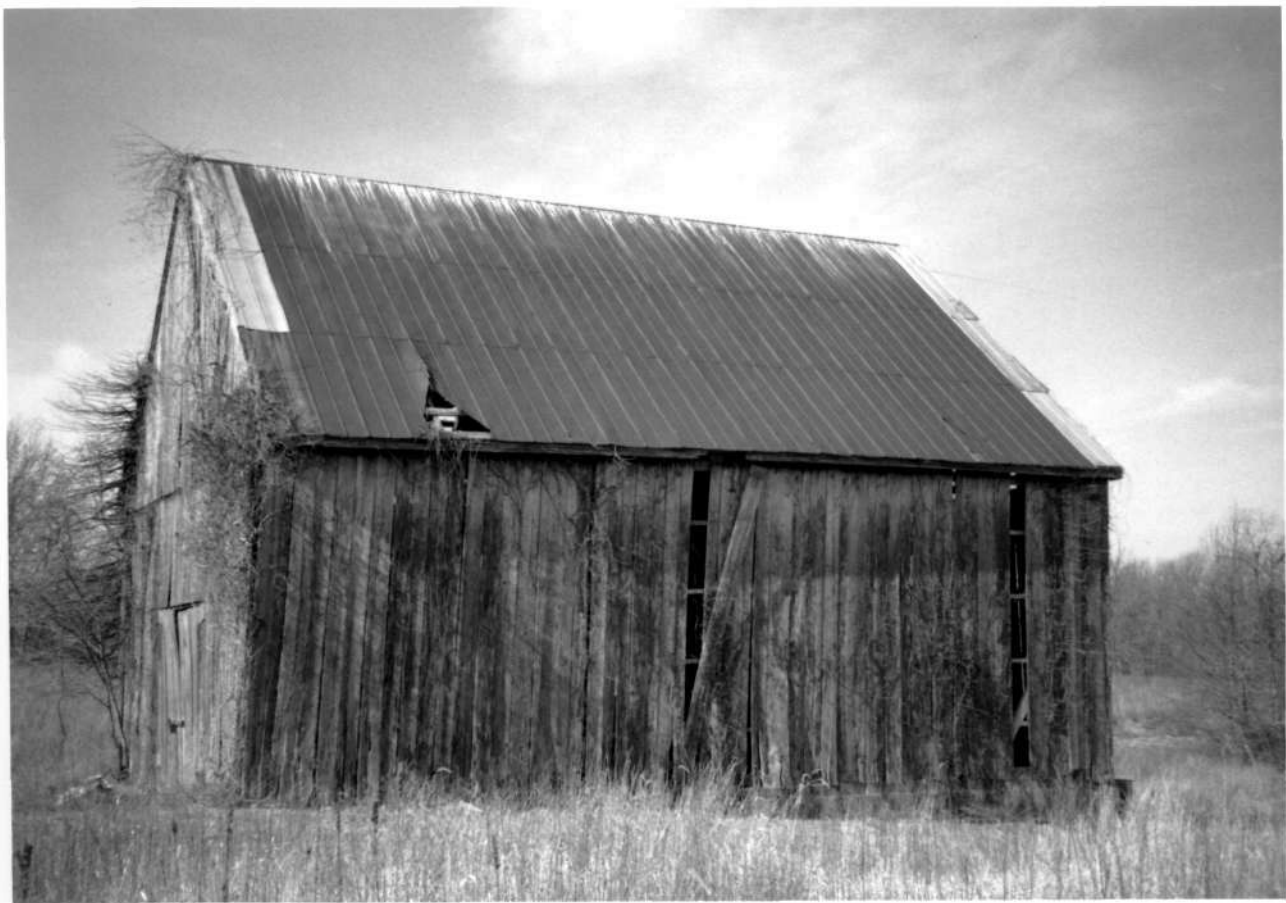
21 of 60

Barn 1 East Elevation

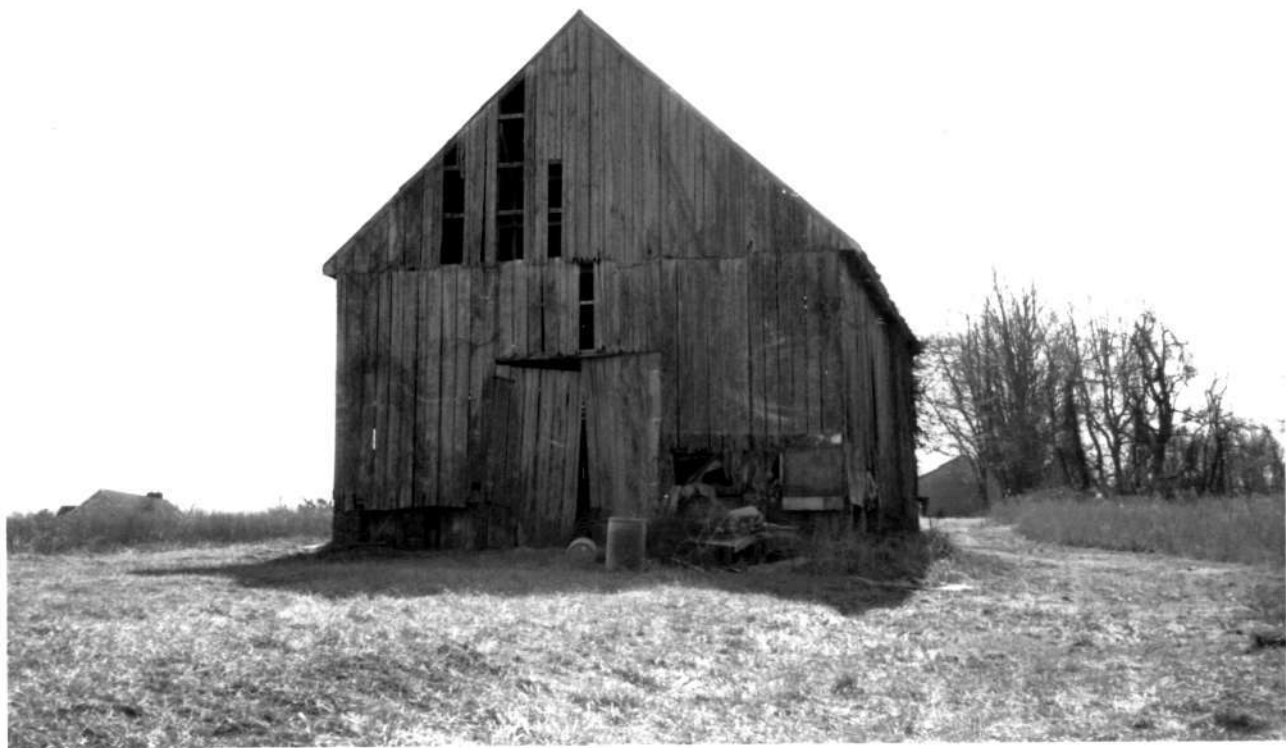
22 of 60

The foundation at the barn's northwest elevation is concrete masonry block. There are also tall brick piers along the north façade that have sheet metal infill. On the northwest corner is the stripping room. The room has two window openings that no longer have mutins or glazing. This room was used for stripping tobacco once it was dry. There are double batten, wood plank doors on the north and south elevations. They are secured by a wooden latch. The doors sizes signify the ability to drive modern, twentieth century farm equipment into the barn.

Barn 1 North Elevation

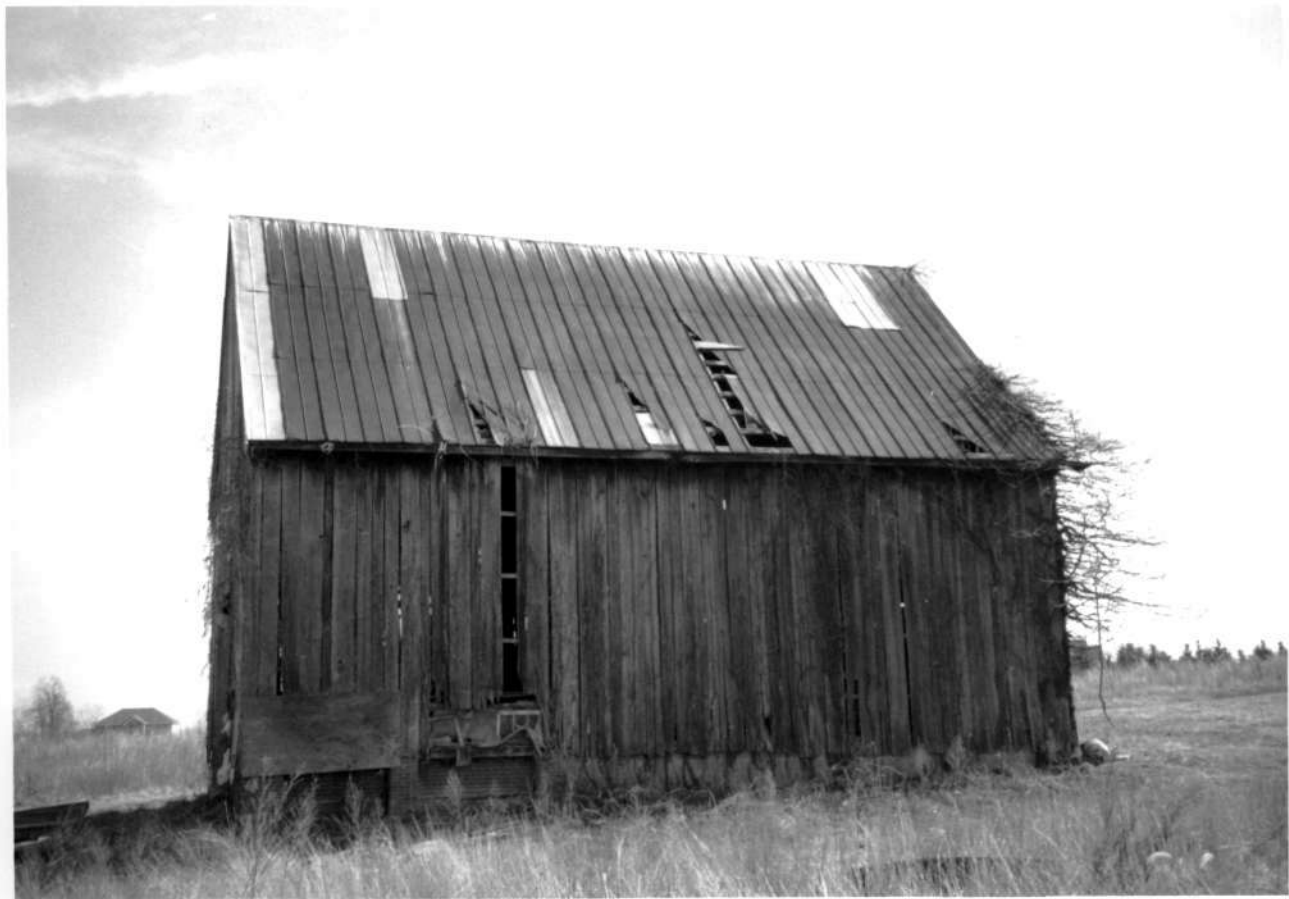
23 of 60

Barn 1 West Elevation

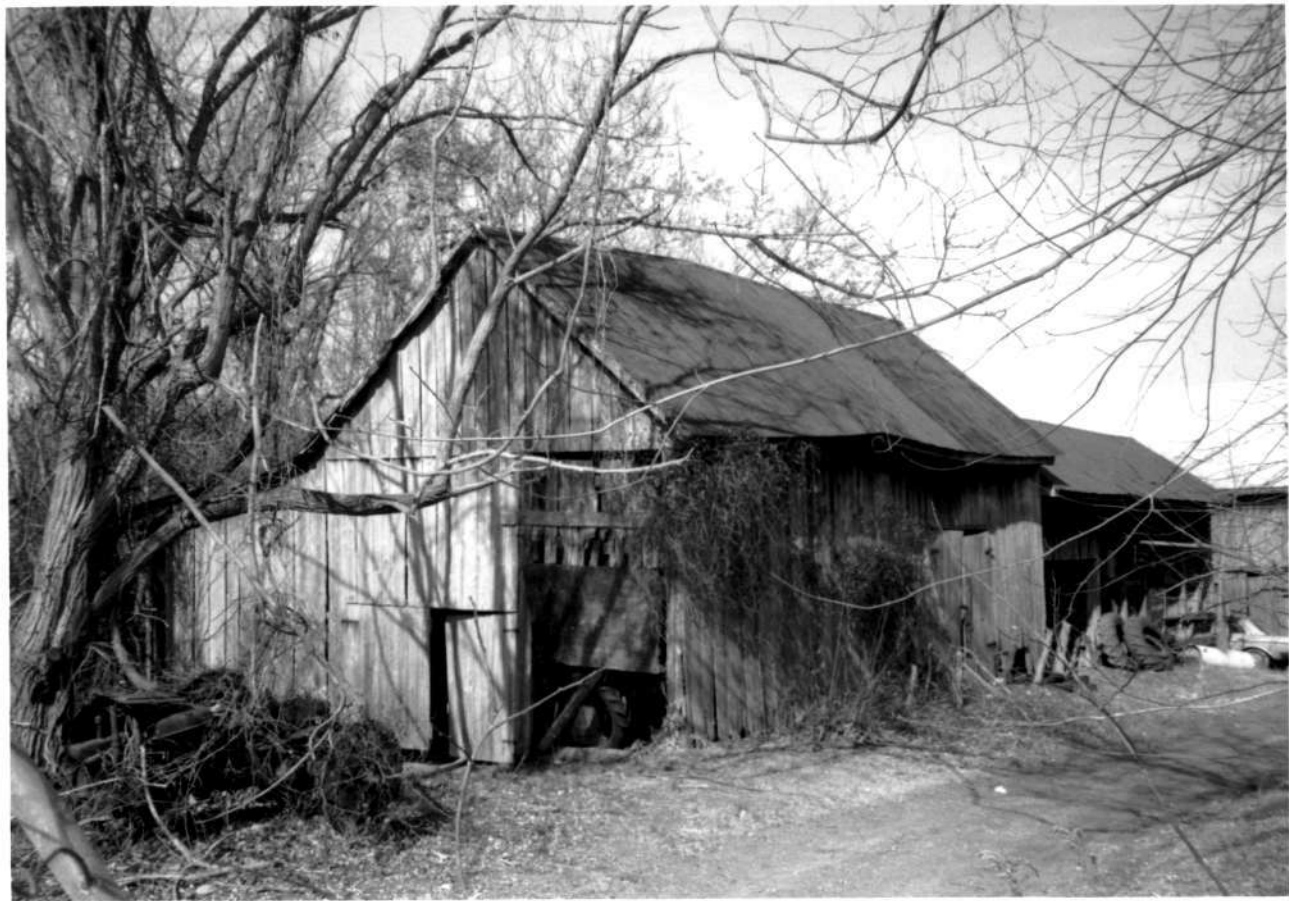
24 of 60

The corn crib has a steeply pitched, standing seam metal saltbox roof with an overhang. The corn crib is wood-frame, mortise and tenon construction. The exterior is clad in wide, rough-hewn planks resting on a stone foundation. The corn crib's massing was likely altered when the tractor shed was added to the south elevation. Only on the east façade is the original corn crib framing visible. There is a batten, wood plank entry door with a modern, six-pane awning window to the south on the east façade. A second entry to the corn crib is on the north elevation through double, batten wood plank doors.

The next building constructed was a tobacco barn slightly to the south of the corn crib. Constructed in the early-twentieth century is has a double aisle plan and an asymmetrical roof. The front-gable metal standing seam roof is of steep pitch and has a shed-roof bay on the west elevation. The planks are affixed with wire cut nails. The foundation is not visible; the barn is of wood-frame construction. The exterior is clad in machine cut, vertical planks that are not flush. There are small double batten doors with hinges on the south elevation and standard, double batten doors with hinges on the east façade. There are numerous "cut outs" in the barn, likely done as the barn's function changed from drying tobacco to storage. One window opening on the east façade does not have mutins or glazing. A second cut out is on the south elevation's east bay. The vertical planks have been removed to the roofline and reused wood has been used to secure the opening. This cut out was most likely done to provide storage for farm equipment that would not fit through the older, narrower doors.

Barn 2 Southeast Facade

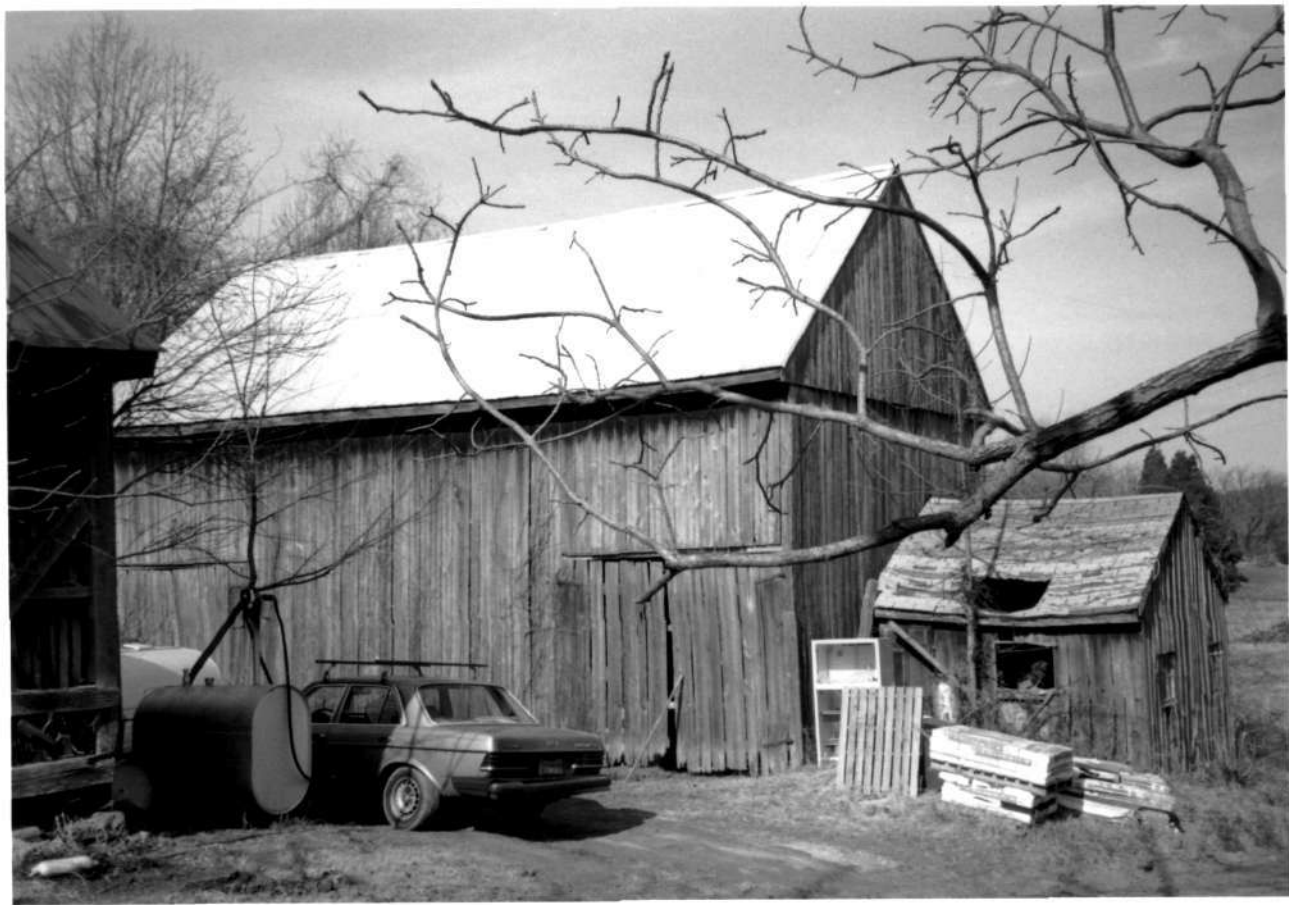
28 of 60

Barn Three has a steeply pitched, metal standing seam, front-gable roof with slightly overhanging eaves. Constructed in the 1950s by the current owner's grandfather, Herbert Ireland, the barn is wood-frame with a concrete block pier foundation. The exterior is clad in machine-cut, flush wood vertical planks of consistent width. There are two sets of double, batten wood plank doors on the south facade. Although

Barn 3 South Facade

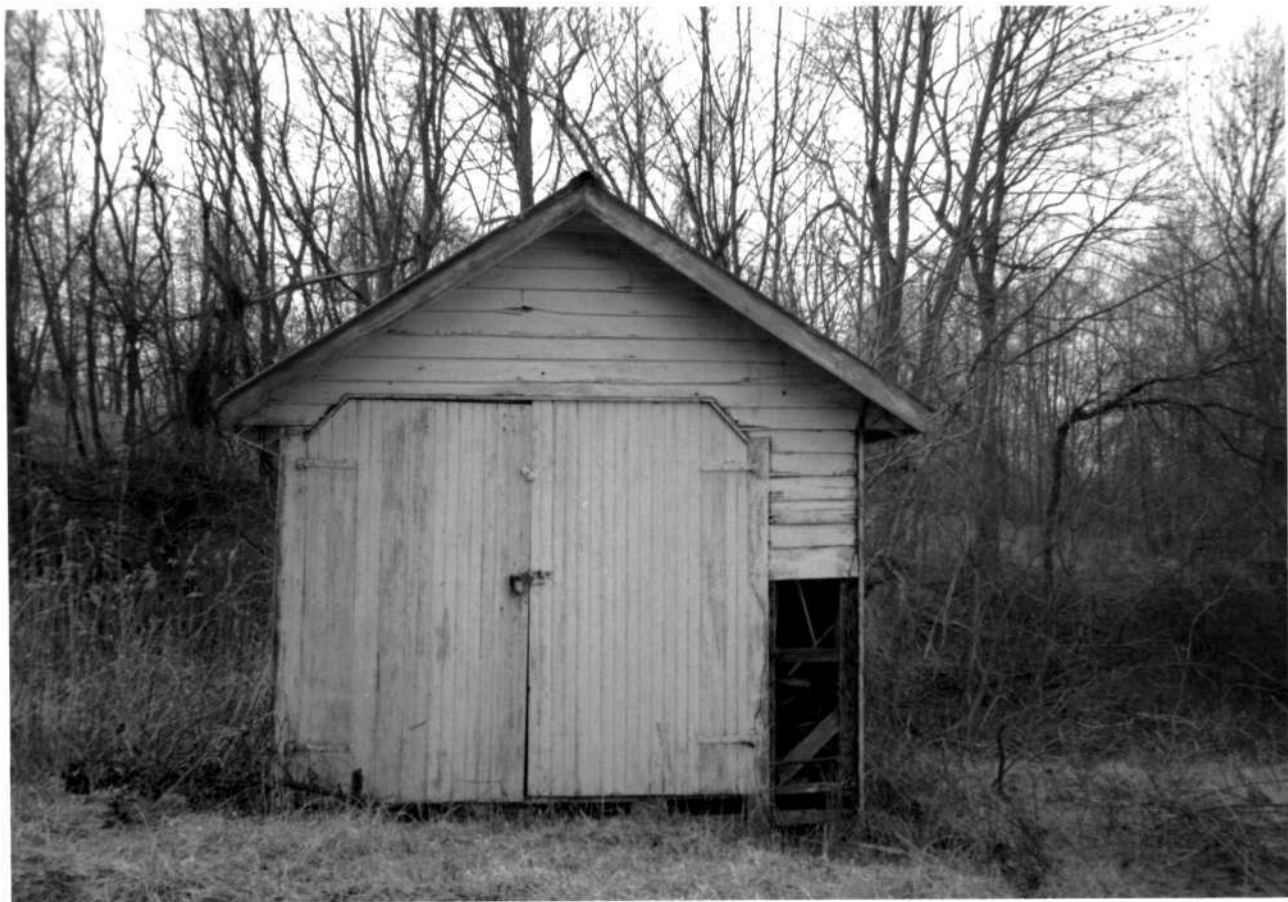
32 of 60

Shed Four is located to the south off of Patience Place prior to the access road and the main farmhouse parcel. The shed does not meet Patience Place at a right angle but rather at a thirty degree angle with the principal façade facing northeast. The shed is at the roads end surrounded by a rolling agricultural field and undeveloped forest north of Barn Three. The outbuilding is a one-story, one-by-one bay building with a rectangular plan. The steeply pitched, metal standing seam shed-roof has a thick cornice and overhanging eaves. The building is of wood-frame construction with a foundation that is not visible. The exterior is clad in narrow, wood weatherboard. The batten double door is asymmetrical on the northeast façade in the southeast bay. The corners of the door are cut on an angle. The exact use of this shed is unknown. Alterations have been made to the shed over the course of its use. The exterior sheathing on the west elevation meets in the middle of the shed as if the shed was expanded. The exterior is no longer weatherproof as horizontal boards are missing on the northwest façade adjacent to the door as well as on the west elevation.

Shed 4 East Facade
